PROJECT CASE STUDY

Location: South Bend, Indiana
Engineer: n/a (in-house design)

Description

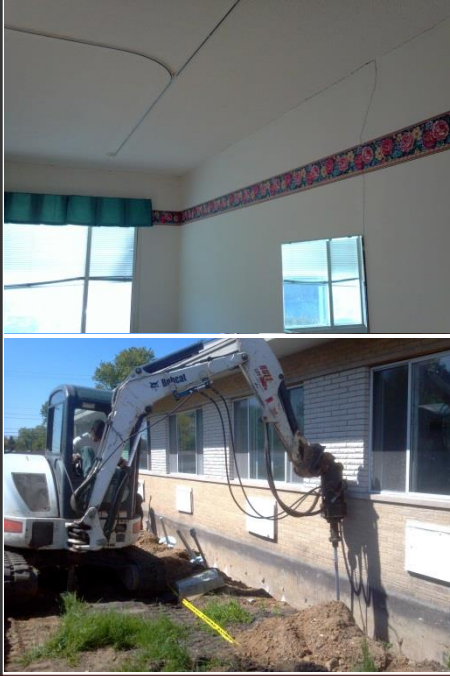
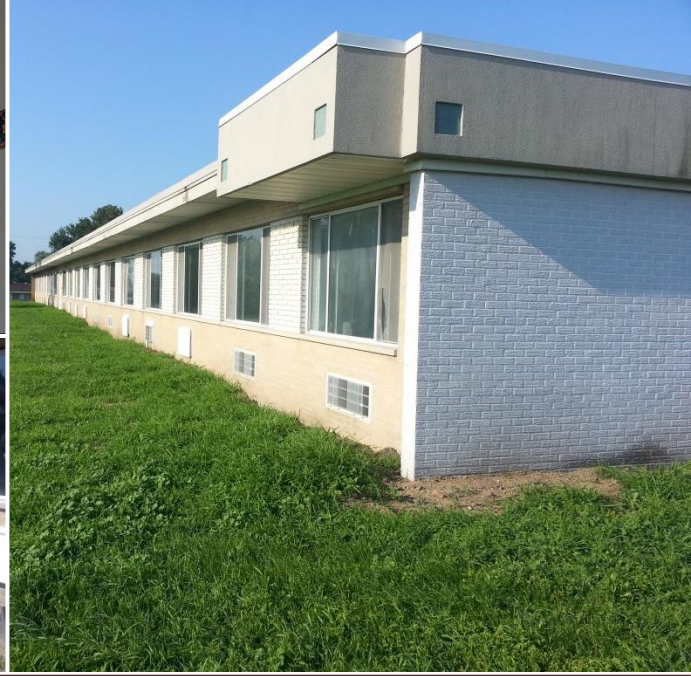
This former assisted living facility was undergoing a full renovation when plaster cracks were discovered along the entire East wall of the facility. This section of the building rests on high ground with slopes of about 8' in elevation to the East and South sides. Minor settlement of the foundation was noted in these areas.

The foundation along the East wall needed stabilization to accommodate the interior renovations. Any continued movement of the foundation would cause additional damage to repaired plaster walls and ceiling areas. To get the facility up and running with staff and residents, these repairs were conducted under a sequence of phases with oversight by the facilities director.

construction documents, the condition and construction method for foundation and footing were unknown prior to excavation.

3D Structural designed a repair plan consisting of 39 A.B. Chance Helical piers spaced 5'o.c. to be installed to an average depth of 14'.

All 39 piers were installed over a two-day span, including excavation and backfill of soils. The renovation project was able to commence without delay and without any further concern of movement of the foundation.
