PROJECT CASE STUDY

Location: Beverly Shores, Indiana
Engineer: Archistructure Eng
Completed: September 2014

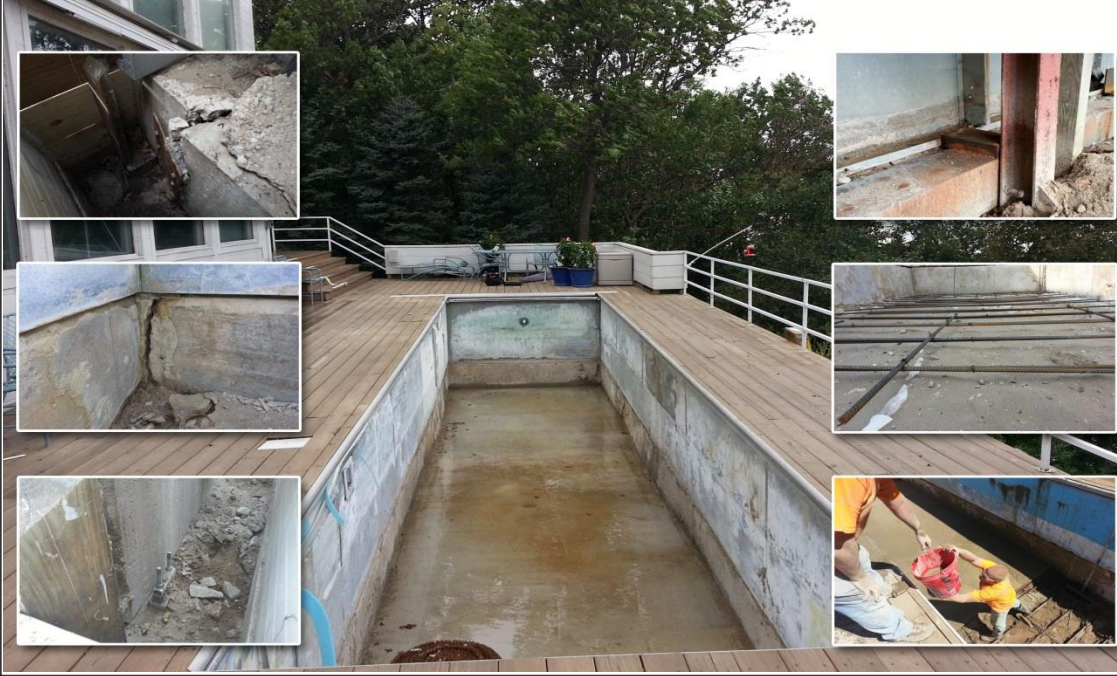
Above-ground pool with concrete base and sheet steel framing suffered massive foundation failure as a result of the harsh winter of 2013. Water left in the pool froze and expanded, causing massive cracks and sheering of the concrete walls and complete tears in the liner. This sheering and release of the water when thawed caused settlement of the pool and deck by about 3".

With consideration of the retaining wall and helical piers installed in 2010, we believed the best approach would include the installation of 7 additional A.B. Chance SS5 helical piers on the settled pool walls, along with the construction of a steel cage connected at the top of the walls. Archistructure Eng added a rebar detail with 12" embedment and 18" overlap to tie in the bottom of the concrete walls. A concrete bottom was poured with 8" thickened edge tapering to 4" in the center. The corners were to be lagged together using angle brackets and all foundation cracks were epoxied.

The project was delayed by an extended stretch of rain, but was completed on budget. The pool foundation was leveled by a total of 3" and completed tied together. The deck was also leveled and the retractable cover was able to operate properly. The pool will be fully operational for the 2015 summer.
